Upper Heaton Accessibility Action Plan April 2023

4.1 - ACTION TABLE

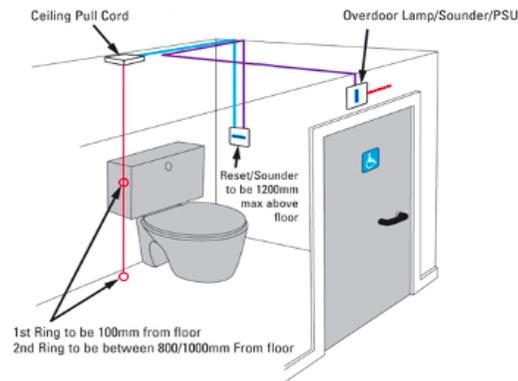
13.11

The cord alarm in reception was not freely hanging within a suitable distance of the floor.

The cord alarm on the first-floor facility was marginally high from ground floor level.

The cord alarm in the hygiene room was looped around a grab rail.

The cord alarm in the facility near to the dining area was marginally high from ground floor level.

If cord alarms are not hanging within a suitable distance of the floor, distress calls may go unnoticed.

According to BS8300 - An emergency assistance pull cord should be sited so that it can be operated from the WC and from an adjacent floor area. The emergency assistance pull cord, coloured red, should be provided with two red bangles of 50 mm diameter, one set at a height between 800 mm and 1000 mm and the other set at 100 mm above floor level.

Implement a management procedure to ensure that cord alarms are always kept loose and not tied up.

The emergency assistance pull cord's around school are checked weekly as part of the site PPM's. Any that are found to be tied up are untied and left in the correct position. Email sent out to all staff regarding the correct position for The emergency assistance pull cord's 30/01/2024

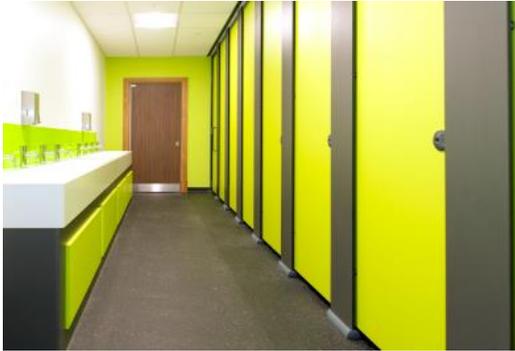
<p>12.4</p>	<p>The compartment doors for the student WC facilities were not well contrasted against the frames.</p>	<p>Cubicle doors throughout should appropriately colour contrasted to identify doors within frames to aid people with impaired vision. A difference of 30 points LRV (Light Reflectance Value) is recommended as appropriate contrast.</p>

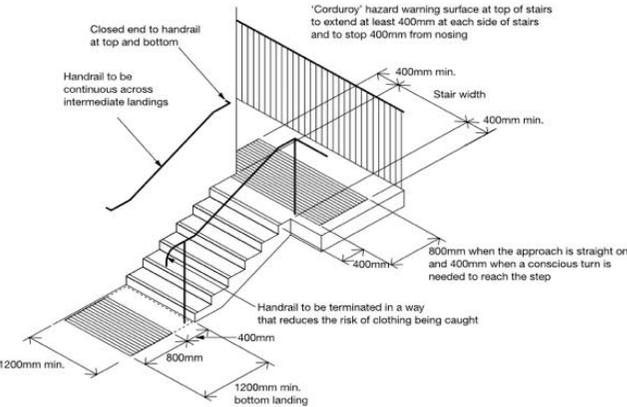
<p>4.1</p>	<p>Tactile paving was provided to the main external steps that lead towards the school.</p> <p>The tactile paving provided to the steps that lead toward the school field featured tactile paving, but these were directly next to the step, rather than the recommended 400mm distance away from the final step.</p> <p>A set of stairs were identified close to the sports hall, within the car park. These steps did not feature tactile paving. The auditor was informed that these steps were not used.</p>	<p>Ensure that tactile paving is appropriately positioned by the external steps, 400mm from the foot landings.</p> <p>BS8300 - To give advance warning of a step, tactile paving with a corduroy hazard warning surface should be provided at the top and bottom of each flight, excluding intermediate landings with continuous handrails. Where the approach to the stair is wider than the flight, the tactile surface should extend beyond the line of each edge of the flight.</p>

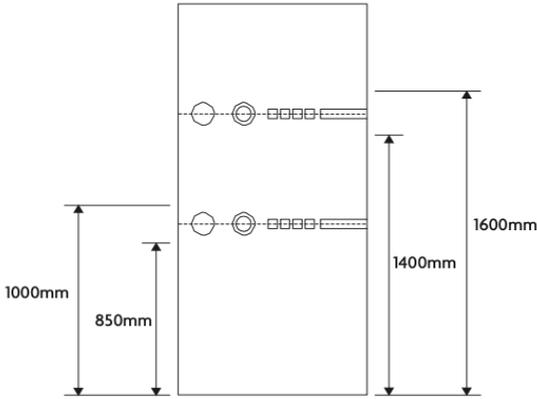
<p>5.1</p>	<p>The main entrance to the school was clearly signposted; however, the entrance doors were not clearly visible from the surrounding frames. Contrast could assist people who are partially sighted towards the main entrance.</p>	<p>Colour contrast should be added to the entrance to ensure that it is clearly visible on approach to aid people with impaired vision.</p> <p>AD M - The presence of the door should be apparent not only when it is shut but also when it is open. Where it can be held open, steps should be taken to avoid people being harmed by walking into the door.</p>	<p>M</p>	
<p>5.9</p>	<p>The entrance doors featured manifestations at two heights. The lobby door to the main entrance featured one door with no manifestations. This could be a collision hazard.</p>

<p>1000mm 850mm 1400mm 1600mm</p> <p>Manifestation can take various forms, e.g. broken or solid lines, patterns or company logos</p>	<p>Well contrasted manifestations should be provided at two heights to both doors at the lobby entrance.</p> <p>Glazed doors need to have permanent strips on the glass within two zones, from 850mm to 1000mm from the floor and from 1400mm to 1600mm from the floor. These strips need to be contrast in colour (not treated glass) and luminance with the background seen through the glass in all light conditions.</p>	<p>M</p>
